# Colorado River in Eagle County Inventory and Assessment

*Report prepared for the*  
Eagle River Watershed Council

June 2014

Colorado State University  
Civil and Environmental Engineering  
Fort Collins, CO 80523

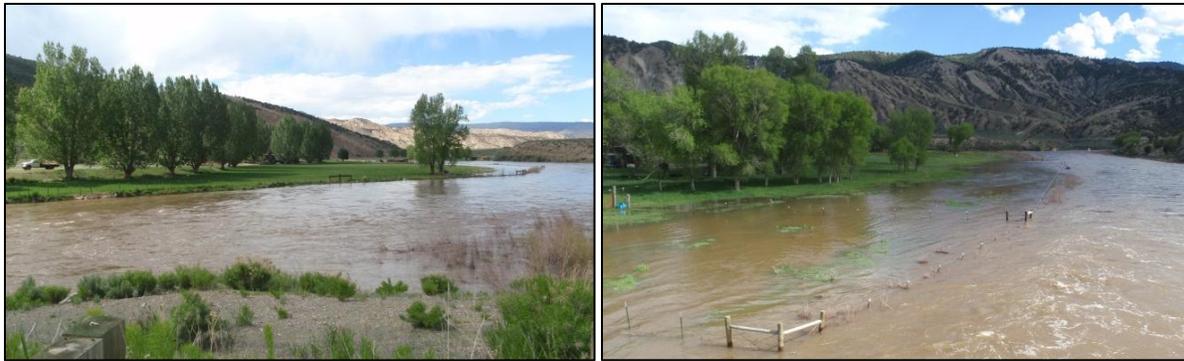
**Figure ES.1 – In the corridor from Red Dirt Creek to Dotsero, many private lands maintain little or no riparian buffer, potentially exacerbating bank erosion and limiting local-scale habitat for animal communities dependent on the riparian zone. An outreach campaign and guidance/support on riparian stewardship for riverside landowners can help improve this issue in the reach, which is experiencing increased recreational use from float boaters and fishermen due to access improvements by Eagle County.**

**Private lands.** Private lands with degraded riparian conditions on the main stem tend to concentrate in the Bond-McCoy and Red Dirt Creek-Dotsero reaches (Figure ES.1), although the aerial extent of mowing and hayfield encroachment, and grazing impacts comprises only 4.1% of the 62-mi project area. A limited education/outreach campaign with landowners may generate voluntary efforts to refrain from mowing or otherwise developing riparian zones further. Emphasis for property owners could be placed on the improved bank stability and sediment

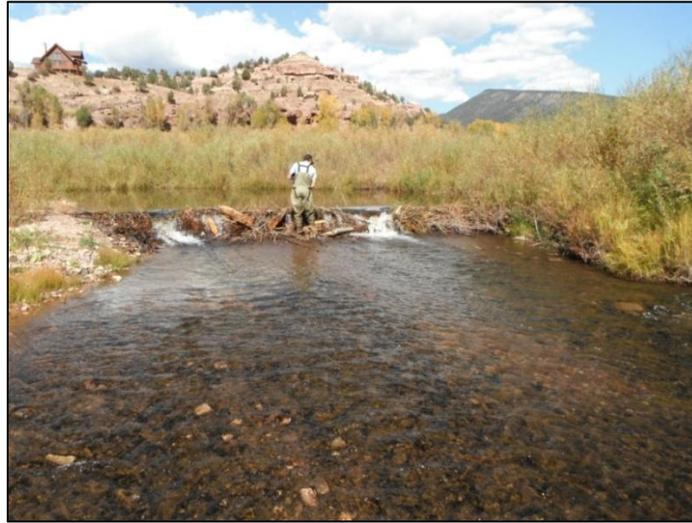
Figure 2.16 – Beaver dam located on Rock Creek directly upstream from the confluence with the Colorado River.

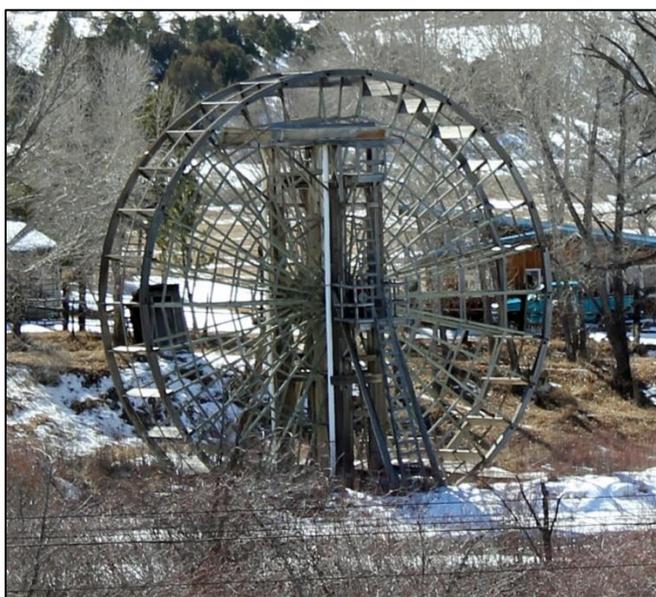
**Figure 2.42 – The largest waterwheel in Colorado was built in 1922 just south of McCoy.**

As settlers moved into the area they brought herds of cattle and began to ranch the area. To support cattle year round they began to divert water from the river to irrigate surrounding hay fields. One of the remaining artifacts of the era is the McCoy waterwheel (Figure 2.42). Constructed in 1922 by local ranchers, it is believed to be the largest remaining waterwheel in Colorado. Waterwheels were the primary way ranchers could easily irrigate their fields by delivering water from the wheel buckets to ditches that ran into the hay fields. This technology was eventually replaced by the electric pump.

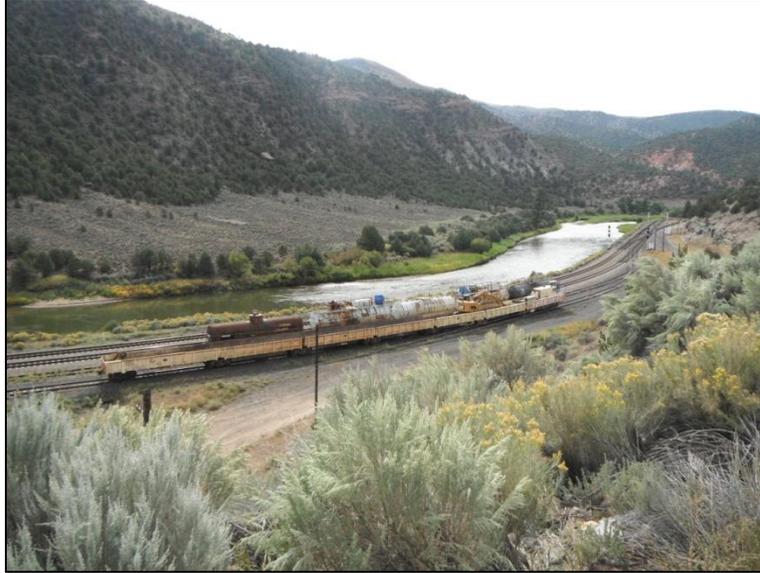
**Figure 2.44 – The railroad tracks follow right alongside the river in many areas of the confined valley.**

Due to the river's narrow confined valley, the railroad generally runs directly adjacent to the river. Riprapped channel banks along the elevated tracks are common throughout the valley (Figure 2.44). In addition to the railroad, the Colorado River Trough Road (County Road 1) also encroaches upon the river as it follows the confined valley. It is not uncommon for the railroad and road to completely border the river on both sides.

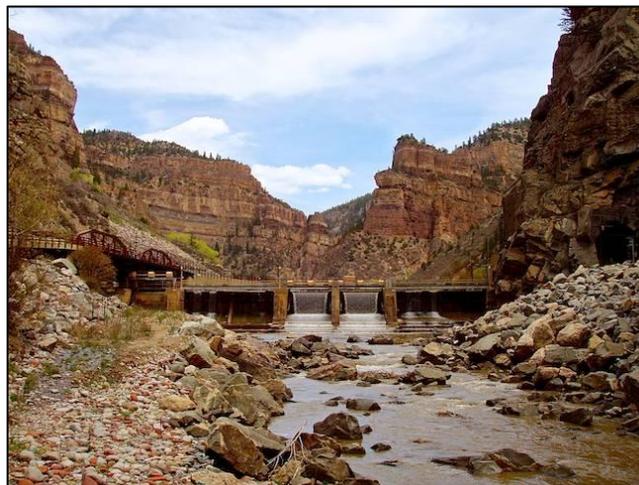
**Figure 3.7 – Shoshone Dam diverts water from the Colorado River to the Shoshone Power Plant downstream (<http://krcc.org/post/shoshone-power-plant-big-dog-river>).**

The most important water rights for maintaining flows in the main stem river are actually located downstream of the study area. The water rights held by the Shoshone Power Plant and the “Cameo Call” (Figure 3.7 and Figure 3.8, respectively) are two of the oldest held on the Colorado River. The Shoshone Power Plant has a right of 1,250 cfs (1902 appropriation) and an additional 158 cfs (1940 appropriation), which makes up a large portion of the water in the Colorado River year round. However, the Shoshone rights can be shutoff during runoff and “relaxed” during times of drought to allow more junior rights held by reservoirs upstream to store water.

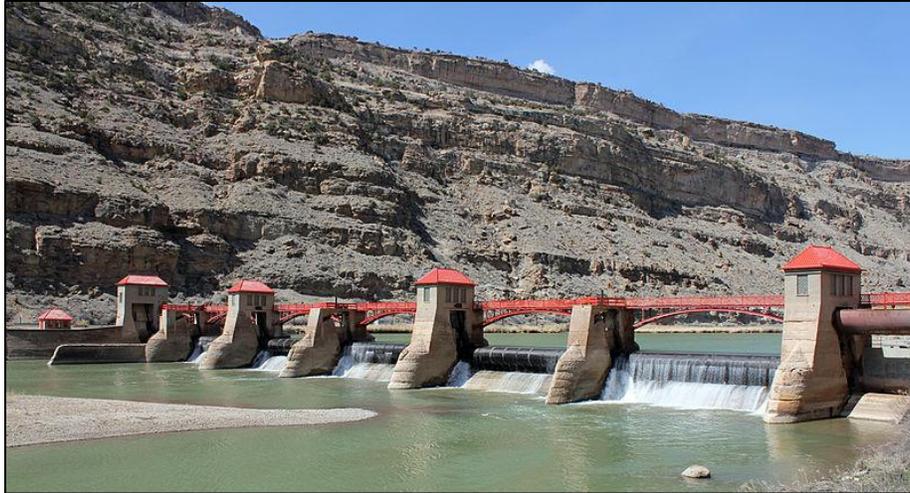
**Figure 3.8 – Grand Valley Diversion Dam ([http://commons.wikimedia.org/wiki/File:Grand Valley Diversion Dam.JPG](http://commons.wikimedia.org/wiki/File:Grand_Valley_Diversion_Dam.JPG)).**

The Cameo Call provides water primarily for irrigation and power in the Grand Valley near Grand Junction. The water rights are owned by five entities in the valley and date back from 1912-1934. The total water quantity owned by the right is 2,260 cfs during irrigation season and 800 cfs during non-irrigation season. Because of their downstream location and their senior standing, water provided for the two water rights actually keeps water in the Colorado River rather than it being diverted to the East Slope. In 2013, as part of the Colorado River Cooperative Agreement, Denver Water and West Slope parties will operate their diversions and reservoirs as if the Shoshone Power Plant was calling for its right even when the plant is not running (CRCA, 2013). This agreement will ensure flows to remain in the Colorado River and provide recreational and environmental benefits; however, the flow requirements for Shoshone and Cameo water rights can also be met by water from the Eagle and Roaring Fork Rivers downstream of the study area. This means that flows in the Colorado River through the study area are not necessarily stable and predictable due to these water rights.

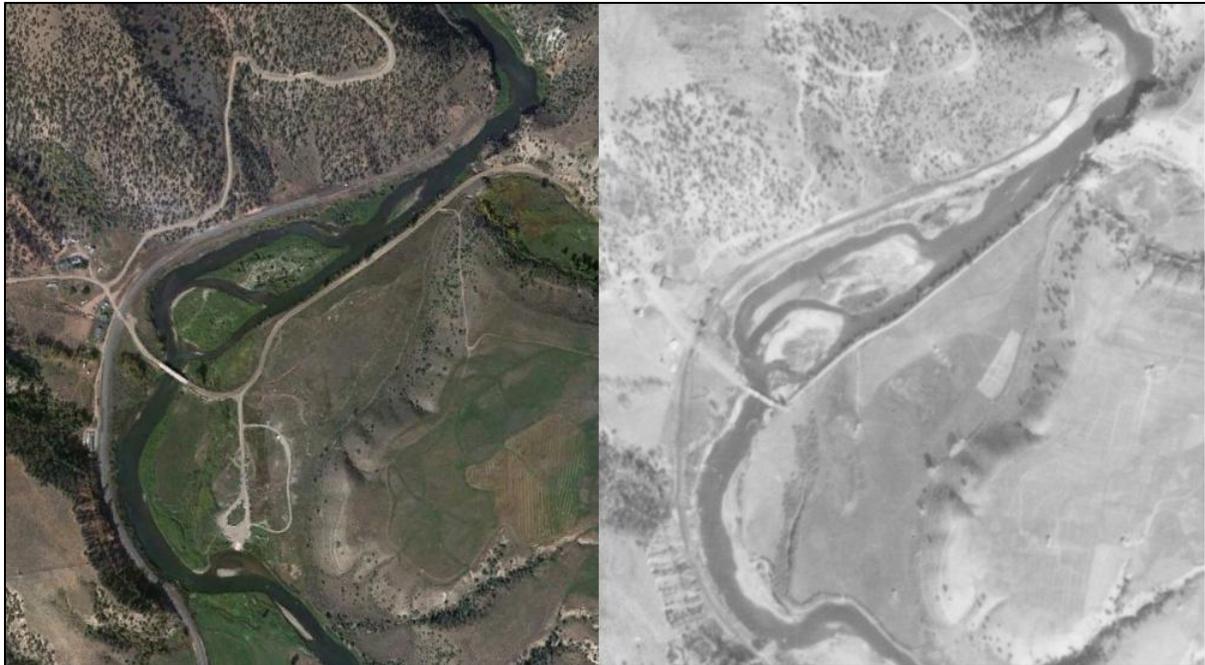
**Figure 3.29 – Aerial photographs: (a) from August 31, 2011 and (b) October 22, 1938 of the Radium Bridge and campsite. The islands and channel margins seems to have become densely vegetated over time.**

In general, the river throughout the study area is mostly confined by steep-sided hillslopes and canyon. Changes in channel morphology through time become harder to discern in confined valleys as the channel does not have the usual room to move across its floodplain. One aspect of a channel in a confined valley that can possibly change through time is the formation and adjustment of islands. Two sets of aerial photographs from October 22, 1938 were compared to Google Earth<sup>®</sup> images from August 31, 2011. The two sets of photographs are of the river above and below the bridge and campsite at Radium (Figure 3.29 and Figure 3.30). It does not appear that the channel width or shape has drastically changed since 1938 in any of the photographs. However, the most noticeable adjustment has been vegetation establishment on the islands and channel margins. In the 1938 photographs, the islands and some channel margins appear to be mostly unvegetated, possibly indicating there were enough frequent disturbances (scouring and/or extended inundation) by higher flows preclude vegetation establishment. The encroachment of vegetation since 1938 may indicate flows are no longer disturbing these areas frequently enough to prevent vegetation establishment. It is important to note that there was some diversions pre-1938. However, construction did not begin on the C-BT Project until 1938 and water was not stored in reservoirs or diverted until the 1940s.

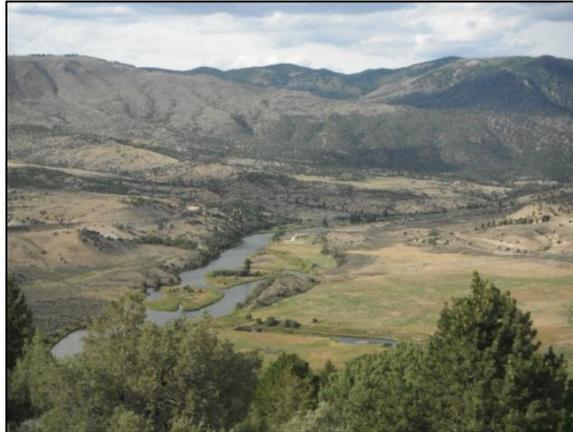
**Figure 3.32 – Looking upstream at the Pumphouse section before it enters Little Gore Canyon.**

Downstream from Pumphouse, the river winds its way through a wider but still confined floodplain (Figure 3.32). The sinuosity of the reach was 1.17. Willows lined the banks along with

a few pines. Sagebrush was dominant in the sparsely vegetated upland. Some older narrowleaf cottonwoods were present along the floodplain but no regeneration appeared to be occurring.

The substrate at Pumphouse consisted of large boulders and cobbles transported from Gore Canyon and deposited on the flatter valley floor as a result of decreasing stream power. The average  $d_{50}$  of a single transect sampled at Pumphouse was 118 mm. Fine gravel and sand were abundant around the larger bed material throughout the reach. The average embeddedness was 30% and the average percent fines, algae, and coarse material were 6%, 62%, and 31%, respectively.

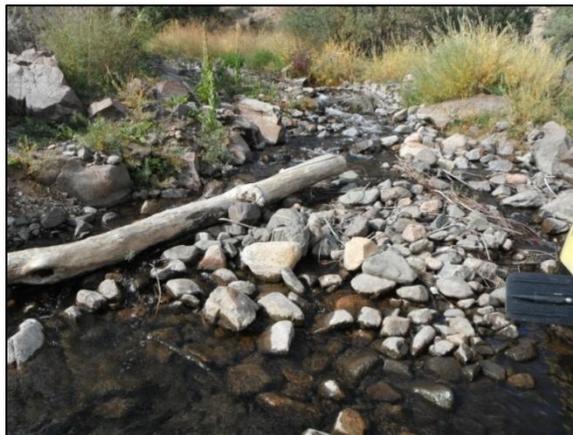
**Figure 3.33 – The mouth of Blacktail Creek before it enters the Colorado River.**

Little Gore Canyon is a narrow, steep canyon formed in gneiss, schist, and granite rock with the railroad track located directly adjacent to the river. Willows were established on the lower riprap banks of the railroad track. Blacktail Creek joins the Colorado River at the bottom of Little Gore Canyon (Figure 3.33). A small confluence bar consisting mostly of cobble and gravel had formed at the mouth of Blacktail Creek. An active beaver dam was located upstream from the mouth.

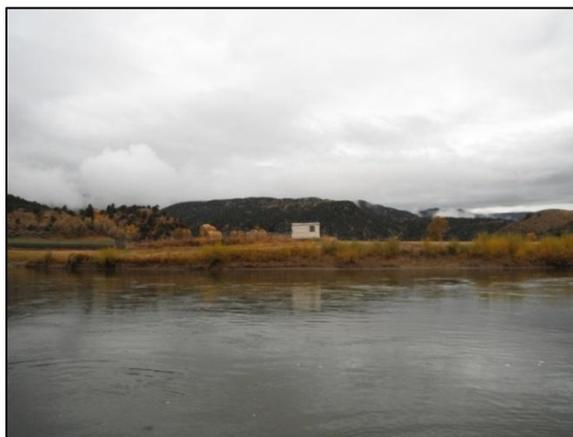
Downstream from Radium, a hay field was mowed almost to the tops of banks leaving only a narrow ~5 ft riparian strip along 0.6 mi of river bank (Figure 3.36). From here, the river enters the Red Gorge, a narrow and steep-sided granite canyon (Figure 3.37). At the downstream end of the gorge, the bed material noticeably fined from cobble to gravel and sand. Deposition of fines in back eddies became more prominent (Figure 3.38). Closer to Rancho Del Rio the river was dominated by glide habitat. The bed material at Rancho Del Rio consisted of gravels, sand, and fines with a few cobbles (Figure 3.39). The geologic history of the area indicated that multiple large landslides created a debris fan of glacial alluvium in the area. This may help explain the flatter bedslope and smaller bed material. Unvegetated sand bars were also present, indicating a depositional area. Rancho Del Rio is located on river left (Figure 3.40).

**Figure 3.36 – A hay field downstream of Radium was observed leaving a very narrow (~5 ft) riparian buffer.**

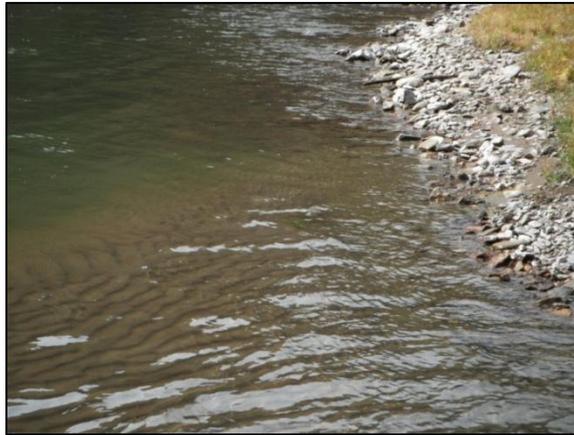
**Figure 3.38 – Sand deposition in back eddy areas is more prominent directly downstream of Red Gorge.**

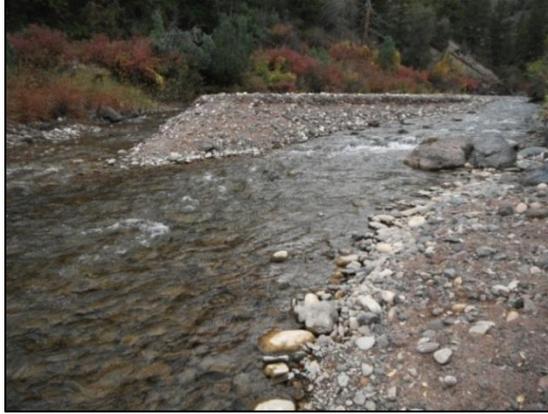
Glide habitat with a depositional sand bed dominated from Rancho Del Rio downstream to the Colorado River Trough Road Bridge. Below the bridge, the bed material coarsened again. The river alternated between flat glides and plane-bed morphology in this location. The road and railroad both parallel the river on river right through most of the reach (Figure 3.41). Closer to State Bridge, the river steepens and exhibits some pool/riffle sequencing. The Piney River enters the Colorado River just upstream of State Bridge. A large confluence bar at the mouth of the Piney River consisted mostly of cobbles, gravel, and sand (Figure 3.42). The sinuosity of the reach was 1.16.

**Figure 3.42 – Looking upstream at the mouth of the Piney River. A large confluence bar has formed.**

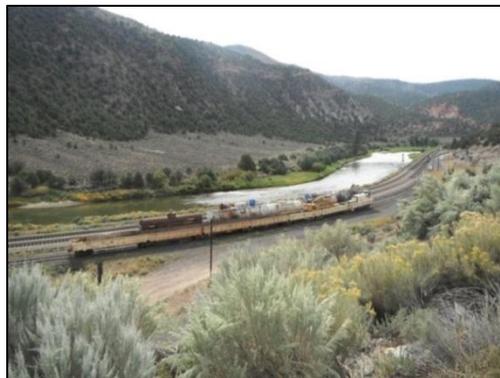
Directly downstream from State Bridge the valley narrows as the river enters a sandstone canyon. The railroad is directly adjacent to the river most of the way to Bond (Figure 3.43). A few willows had established along the toe of riprap banks below the train tracks but ~1 mi remained unvegetated (Figure 3.44). Riparian areas not encroached by the railroad had dense willows, narrowleaf cottonwoods, and upland grasses. Narrowleaf cottonwood regeneration was occurring along the campsites at Windy Point. Bed material in the riffles appeared armored and proliferations of long filamentous green algae were evident. Plane-bed morphology dominated the reach but there was an occasional pool/riffle sequence. The sinuosity was the lowest of all sections of the reach at 1.05.

**Figure 3.43 – Looking downstream above Bond. The train closely parallels the river throughout most of this reach.**

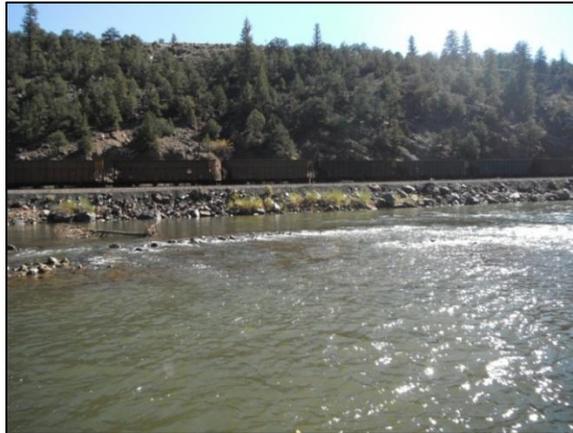
**Figure 3.44 – Some willows have established on the riprap banks along the train tracks.**

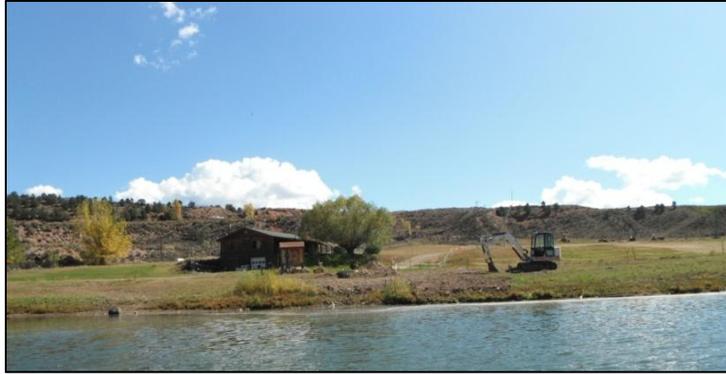
In the wider river valley below Bond, hay fields became more prominent in the floodplain (Figure 3.45). Most of the hay fields had a small riparian buffer <50 ft that could be widened to increase benefits to the river. There was evidence that some private landowners mow to the top of bank, and in some instances, the edge of water in this reach (Figure 3.46). There were isolated patches of regenerating narrowleaf cottonwoods (Figure 3.47). A few mature plains cottonwoods were spotted above and below Catamount but no regeneration was occurring. Most of the riparian vegetation consisted of dense willow, narrowleaf cottonwoods, and upland grasses. Pine and sagebrush dominated the sparsely vegetated upland. Dense willows covered 22 well-vegetated islands within the section. Approximately 1.5 mi downstream of Bond was the most upstream location where Russian olive was observed. Tamarisk was spotted ~3.8 mi upstream of Catamount, but only along banks along the railroad corridor.

**Figure 3.46 – Private land mowed right to the river banks.**

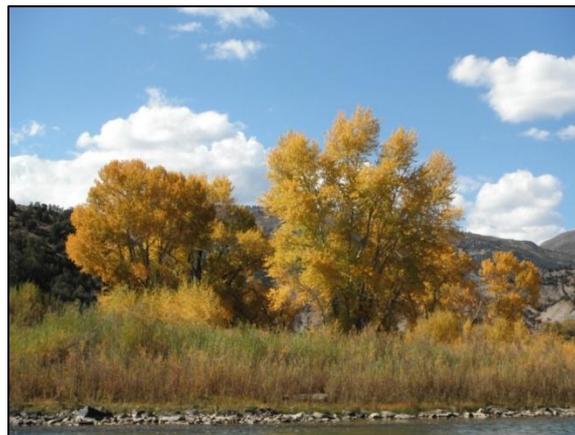
**Figure 3.47 – Multiple age classes of narrowleaf cottonwoods are present along this reach.**

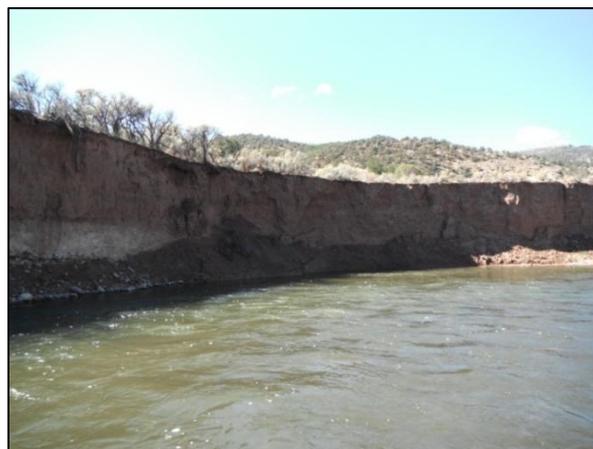
**Figure 3.48 – Bank failures were present in some bends along the reach.**

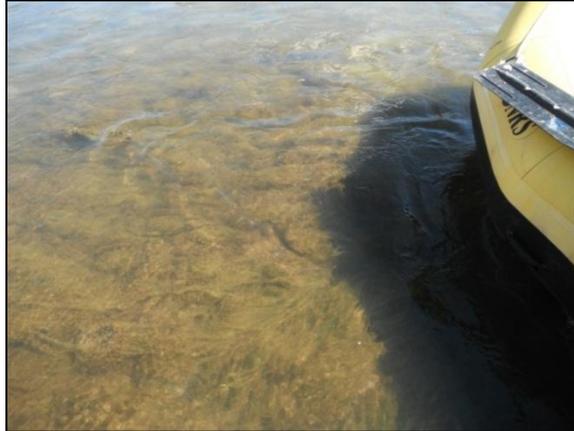
**Figure 3.49 – Boulder and cobbles in the reach were embedded with fine gravel, sand, and fines.**

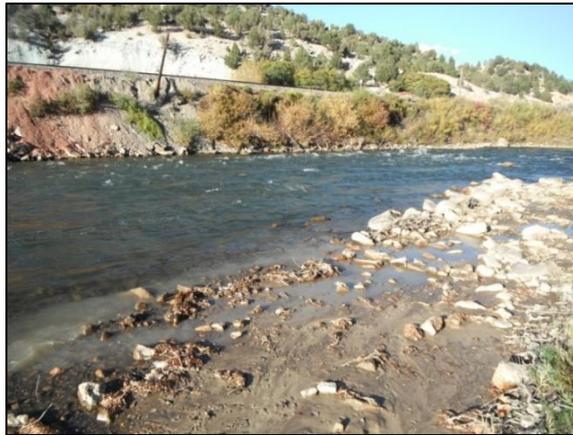
Big Alkali Creek enters the Colorado River at Catamount. The tributary debris fan consisted of large boulders, cobble, and gravel all heavily embedded with fines (Figure 3.51). Downstream from Catamount, the river valley narrows and steepens. The morphology of the river was mostly plane-bed and run habitat was prevalent (Figure 3.52). No islands were present and the sinuosity of the reach was the highest at 1.50. Bed material of runs and riffles observed in this section was composed of armored boulders and cobbles. The substrate was moderately embedded with sand and proliferations of green filamentous algae were also abundant.

**Figure 3.51 – The turbid waters of Big Alkali Creek trickle into the Colorado River on river right.**

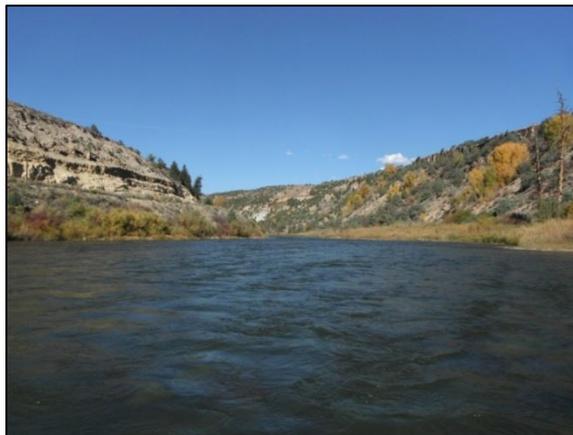
**Figure 3.52 – Most of the Catamount to Burns reach was characterized as run habitat.**

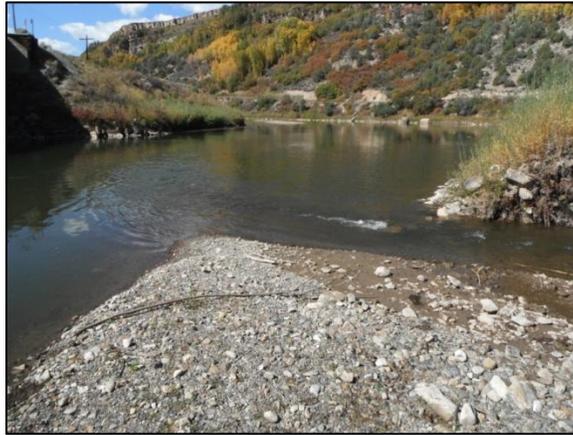
Directly downstream from Burns, Cabin Creek joins the Colorado River. An active beaver dam was present on Cabin Creek just upstream from the confluence. A debris fan had formed at the mouth of Cabin Creek and the substrate consisted of mostly cobble and gravel moderately embedded with fines (Figure 3.53). Downstream from Cabin Creek a long glide section was created by the natural downstream grade control at Rodeo Rapids (Figure 3.54). River otter were spotted alongside their lodge just upstream from Rodeo Rapids.

**Figure 3.53 – Confluence bar at the mouth of Cabin Creek where it joins the Colorado River from the right.**

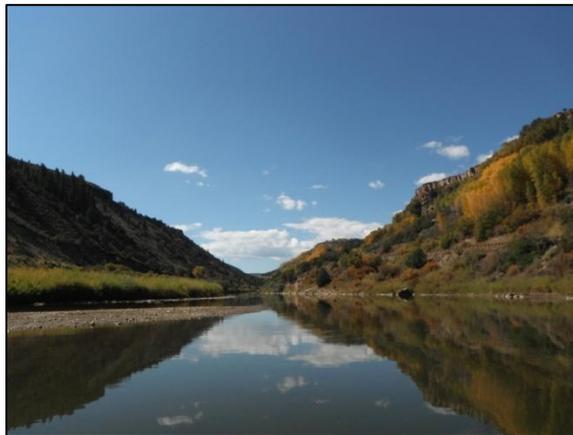
**Figure 3.54 – Glide habitat created by the natural grade control at Rodeo Rapids.**

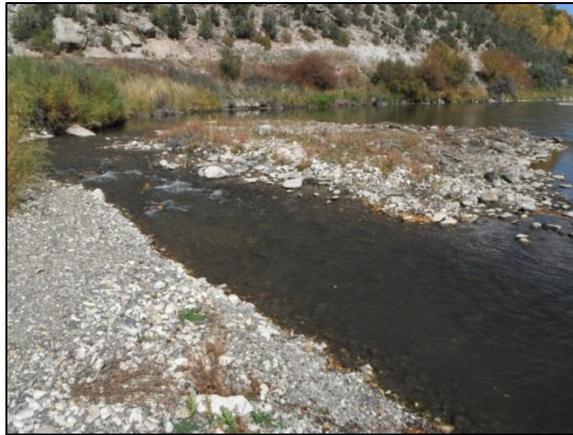
The confluence with Derby Creek is located just below Rodeo Rapids. A large debris fan was present at the mouth of Derby Creek (Figure 3.55). The debris fan deposits consisted mostly of cobble and gravel with some sand and fines. Downstream from Derby Creek, the river valley remains narrow and confined. The aquatic habitat between Derby Creek and Pinball Point alternated between long persistent glides and runs with occasional riffles. Large sand bars were present in back eddies just upstream of Pinball Point (Figure 3.56). The surrounding hillslopes were predominately steep and sparsely vegetated. Erodible sandstone and siltstone on the

**Figure 3.55 – A large debris fan is present at the mouth of Derby Creek where it joins the Colorado River on river left.**

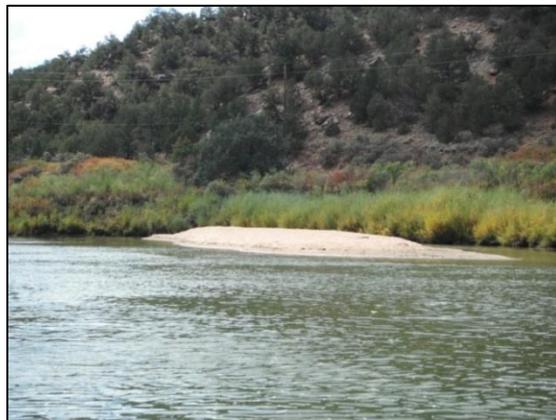
**Figure 3.56 – Large sand bars deposited in back eddies became more prevalent in the lower half of the reach.**

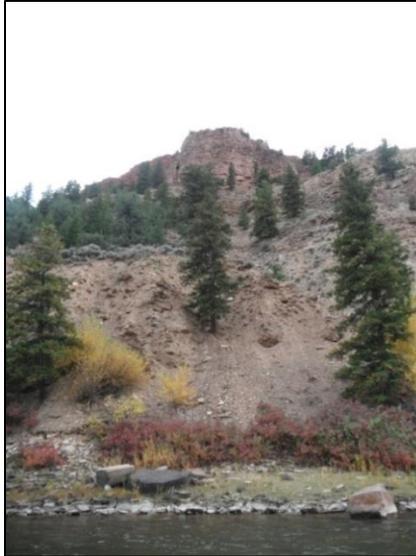
hillslopes were becoming rilled and gullied and directly delivering fine material to the river (Figure 3.57). The influx of sediment continued down through Pinball Point as debris fans formed at multiple gullies and washes along the river (Figure 3.58).

**Figure 3.57 – Typical surrounding hillslope in the reach. The highly erodible faces are delivering sediment directly to the river.**

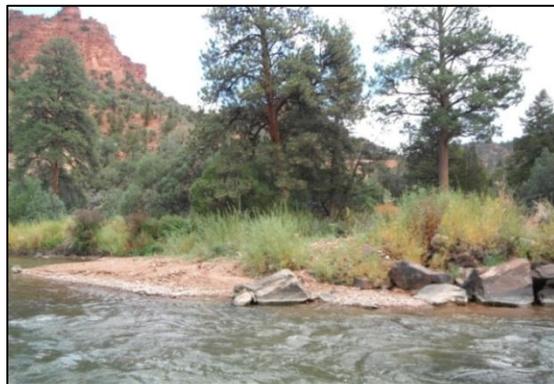
**Figure 3.58 – One of many debris fans formed at the mouth of a gully. The debris fan deposits consisted of cobble, gravel, and abundant sand.**

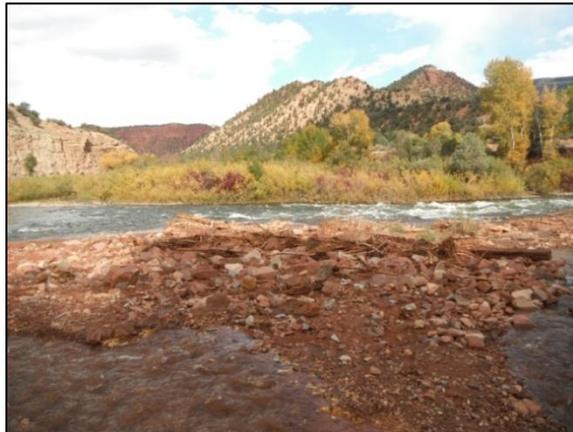
A large debris fan formed where Red Dirt Creek joins the Colorado River consisted of boulder, cobbles, and gravel, all heavily embedded by sand (Figure 3.59). The finer material

was over 2-ft deep in some locations. This red sand was observed in embedded coarse substrates for 1.5 mi below Red Dirt Creek.

**Figure 3.59 – Looking downstream at the Colorado River over the debris fan formed at the confluence with Red Dirt Creek.**

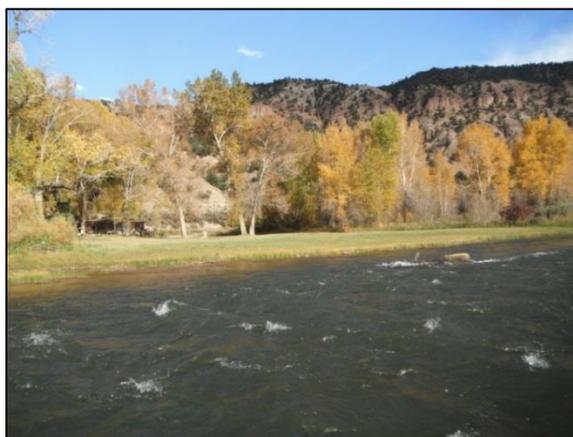
The valley widens downstream of Red Dirt Creek and opens up the floodplain for ranching and private homes. Some private homes had their lawns mowed directly the river edge (Figure 3.60). Most of the mowed banks were undercut and failing. Two landowners have placed riprap along their banks to stop the erosion. Ranches further downstream also had riparian buffers <50 ft if any at all (Figure 3.61). Where there was vegetation along the banks, it was predominantly upland grasses lacking the root depth and density to stop erosion.

**Figure 3.60 – Many private homes have lawns mowed to the edge of the river banks.**

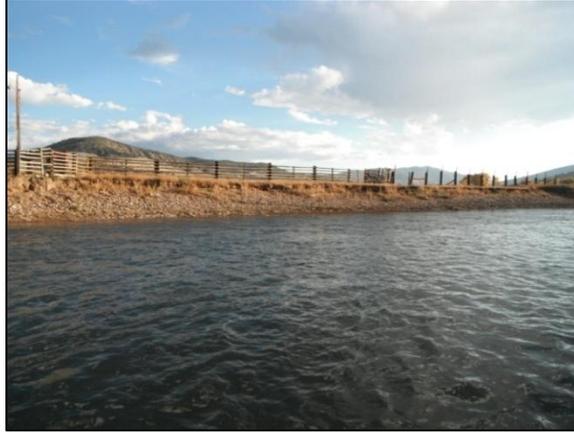
**Figure 3.61 – Bank erosion occurring along a fenced ranch property without a riparian buffer.**

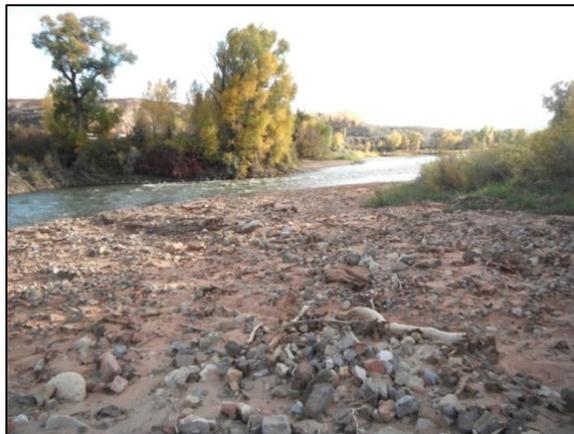
There were multiple ephemeral streams and gullies delivering sediment to the river in this reach. Poison Creek, Willow Creek, and Horse Creek all had large debris fans where they joined the Colorado River (Figure 3.62). Most of the debris fans consisted of boulders, cobble, gravel, and abundant sand (Figure 3.63). Large wood was also observed in the debris fans of larger ephemeral streams. The influx of fine sediment to the river from these streams and gullies was evident in the embedded riffles downstream.

**Figure 3.62 – Looking downstream at the Colorado River over the debris fan of ephemeral Willow Creek.**

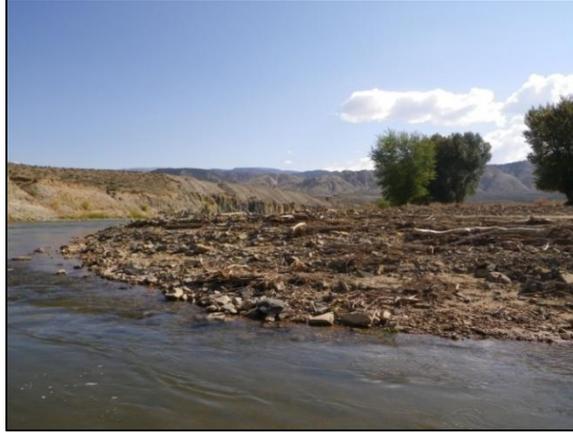
**Figure 3.63 – A large debris fan formed at the mouth of a gully that drains into the Colorado River.**

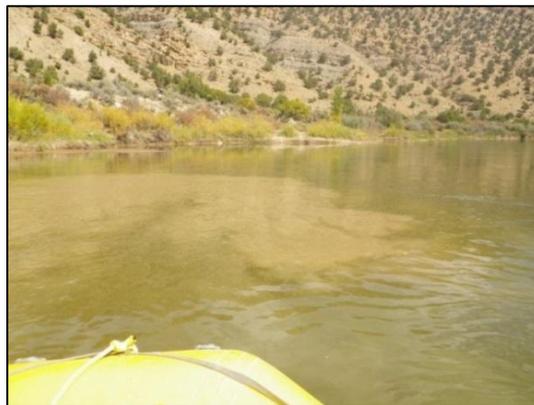
Sweetwater Creek was running turbid during the September 2012 field investigations (Figure 3.64). Rainstorms on July 24 caused debris flows and landslides throughout the lower Colorado Trough Road. However, the lower Sweetwater Creek watershed was had the most damage from mudslides and flooding (Miller, 2012). According to the Eagle County Road and Bridge Department, mudslides occur every summer and the Colorado River Road usually has at least two occurrences per year needing repair (Adams, 2012). The large amount of sediment that entered the river during the storms was responsible for killing thousands of native and non-native suckers, along with a few trout (Figure 3.65) (*Vail Daily*, 2012). The turbidity on our visit was caused by ongoing construction work on the roads and properties upstream (Figure 3.66). The large debris fan at the mouth of Sweetwater Creek consisted of boulders, cobble, and gravel deeply embedded with sand and fines (Figure 3.67).

**Figure 3.64 – Turbid water from Sweetwater Creek mixing with the Colorado River.**

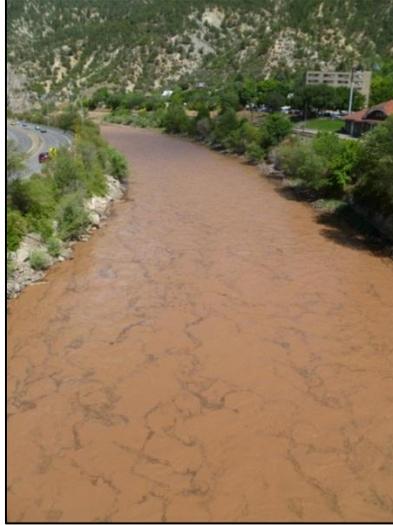
**Figure 3.65 – The Colorado River near Glenwood Springs after the rain storm on July 24, 2012 (Ewert and Bakich, 2014).**

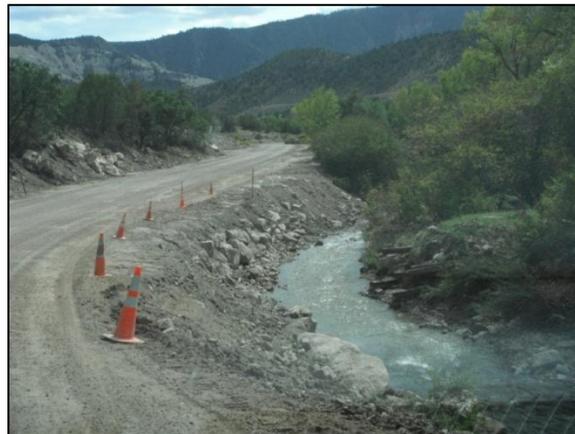
**Figure 3.66 – Ongoing construction, to clean up mudflows that had crossed the Sweetwater Creek road, made the water extremely turbid in Sweetwater Creek.**

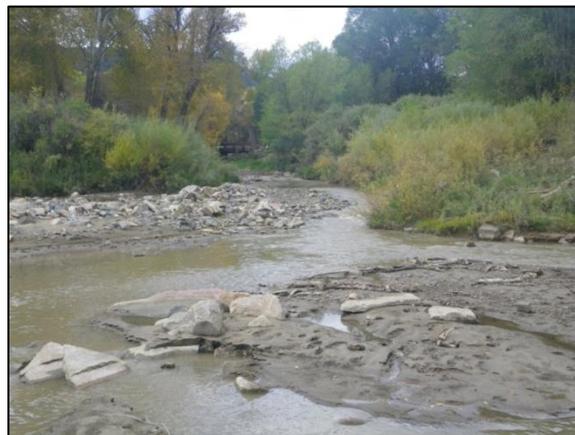
**Figure 3.67 – Sweetwater Creek debris fan where it joins the Colorado River.**

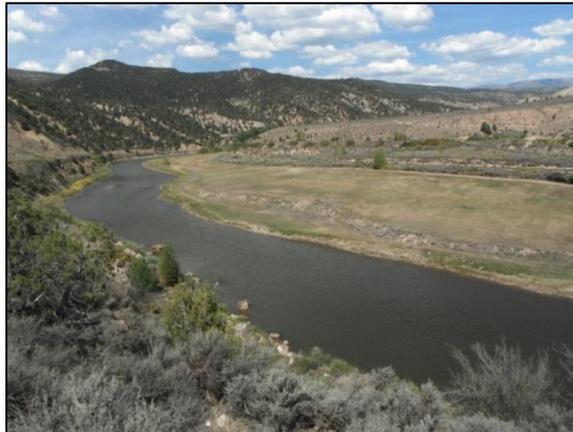
Downstream from Sweetwater Creek, the valley remains confined except for historic large debris flows that have provided enough flat open land for growing hay. Upstream from Lyons Gulch, the geomorphic habitat remained mostly runs with some pools and shoal features created by islands. Sand bars were abundant especially along the channel margins and in back eddies (Figure 3.68). This trend continued downstream of Lyons Gulch where the bedslope flattened out and the riffles continued to be embedded with sand and fines. The geomorphic habitat units were a more diverse mix of riffles and long run/glide habitat (Figure 3.69). The sinuosity of the reach was 1.20.

**Figure 3.69 – Typical section of Sweetwater Creek to Dotsero reach (looking downstream towards Dotsero) Composed of some riffle habitat mixed with longer sections of run/glide habitat.**

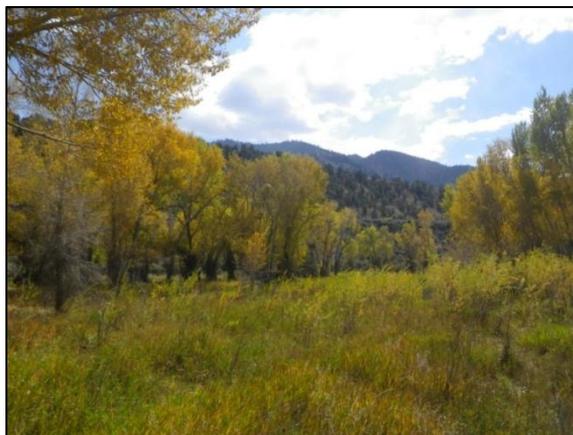
The riparian area through this reach was closely paralleled by railroad and Trough road on either side of the river. Despite this encroachment, the riparian area vegetation appeared dense and healthy. Willows, narrowleaf cottonwood, and upland grasses dominated the vegetation. Narrowleaf cottonwood regeneration was occurring on many of the wider floodplain areas and on larger islands (Figure 3.70). Where the road encroached upon the riparian area

**Figure 3.70 – Narrowleaf cottonwood recruitment was strong in many parts of the riparian corridor between Sweetwater Creek and Dotsero.**

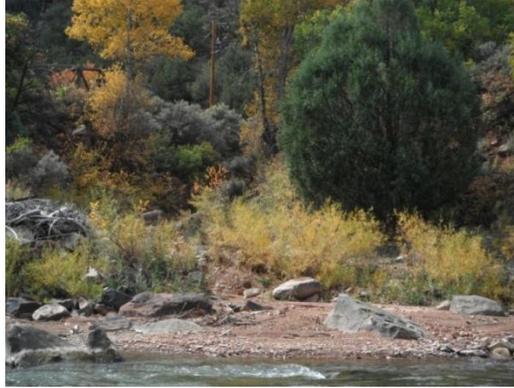
**Figure 3.89 – Typical debris fan from a gully below Catamount.**

As described above, there is a general shift from a mix of igneous and sedimentary rocks to sedimentary-dominated geologic setting moving downstream. This change becomes most apparent downstream from Two Bridges to Catamount where an appreciable increase in sediment delivery occurs due to increasing numbers of gullies and washes (Figure 3.89). This increased influx of fine sediment from surrounding hillslopes, gullies, and tributaries continues all the way to Dotsero.

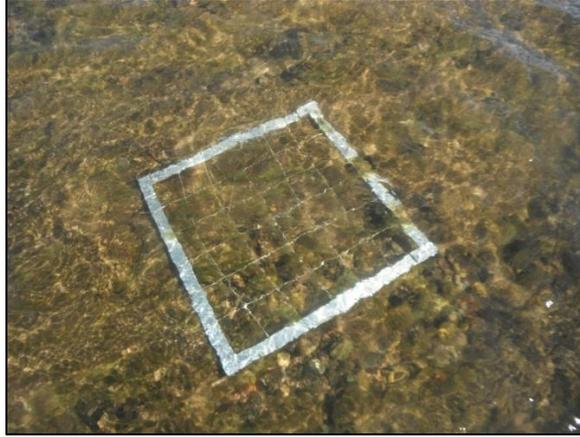
**Figure 3.109 – A systematic point grid frame method was used in combination with a gravelometer to collect substrate data.**

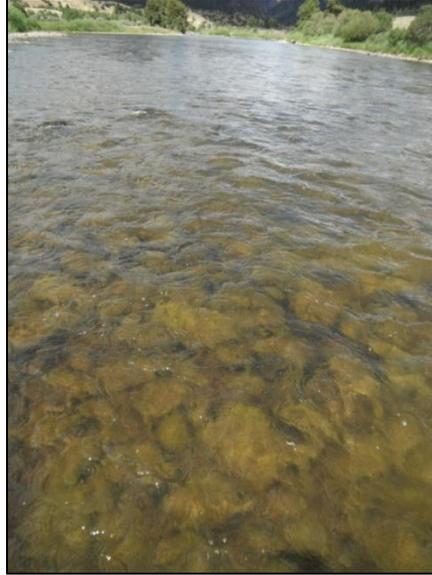
**Figure 3.113 – Green filamentous algae covered most of the post-runoff stream bed at Pumphouse.**

3.112). The percent fines, algae, and coarse data show that more algae were present post-runoff (Figure 3.113) (Table 3.17). These can both be possible indications that flushing flows did not occur at Pumphouse; however, percent embeddedness data dropped from 50% pre-runoff to 9% post-runoff (Table 3.16). It is important to remember that percent fines are based on point samples of the uppermost layer of the bed and not an indication of the depth of the fines associated with the embeddedness data. Sampling methodology for embeddedness is far from standardized potentially making the data relatively imprecise compared to the other measures. However, these results show that removal of some of the finer material occurred in some areas of the channel. General observations of the bed material post-runoff indicate that surficial deposits appeared to be partially removed in the middle of the channel where shear stresses are highest, but were still present in appreciable amounts in high stress zones. Less removal of surficial fines occurred along the channel margins. Movement of larger bed material appeared to not occur based on the increased presence of algae and the bed remaining armored post-runoff.

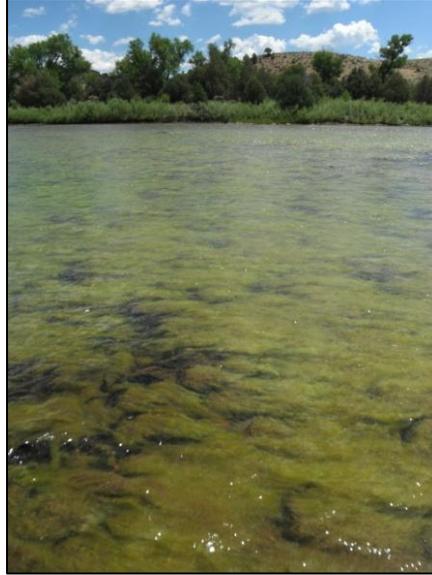
**Figure 3.118 – Green filamentous algae were covering the entire riffle at Above Catamount post-runoff.**

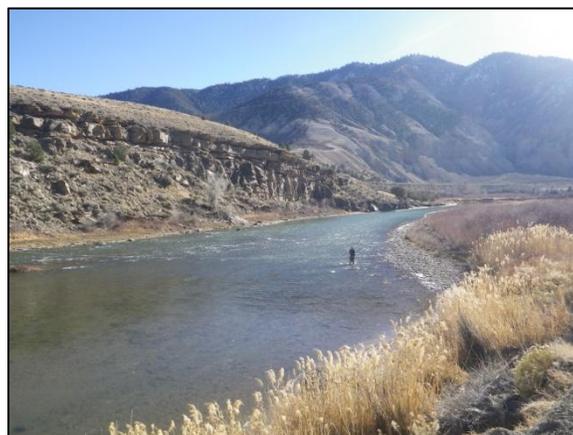
Figure 3.119 – Below Sweetwater Creek cross section located at River Mile 54.1.

Flushing flows results for Below Sweetwater (Figure 3.119) were substantially higher than for other cross sections. This reflects the low slope and large bed material present. Flushing flows were above 66,000 cfs ( $\tau_* = 0.035$ ) for mobilization of coarse material and 22,900 cfs ( $\tau_* = 0.021$ ) for removal of surface fines (Table 3.19). The peak flow in 2013 only reached 3,660 cfs; thus, the shear stress analysis would predict that flushing is highly improbable. Pebble count data show that the percent of bed material  $\leq 8$  mm increased slightly (Figure 3.120). The amount of algae increased and the percent of fines also increased slightly (Figure 3.121 and Table 3.17). However, the embeddedness slightly decreased from 52 to 42% (Table 3.16), although the bed remained highly embedded with sand and fines. It appeared that no substantial change had occurred in the bed material and that no apparent mobilization of coarse material or removal of surface fines had occurred. The decrease in embeddedness could be due to inherent error and imprecision relative to the other measures.

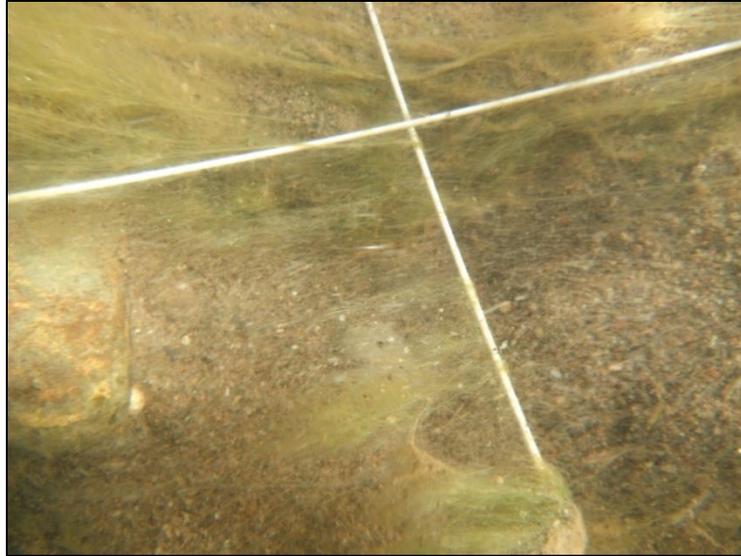
**Figure 3.124 – Small gravel, sand, and fines were filling in interstitial spaces within the large bed material at Above Dotsero post-runoff.**

embeddedness slightly increased and both fines and algae presence increased (Figure 3.124 and Figure 3.125, respectively) (Table 3.17 and Table 3.16). It appeared that the riffle had more fine sediment present than before runoff. Clouds of turbid water rose behind us with each step in the riffle (Figure 3.126). Overall, the Above Dotsero site showed no evidence of coarse substrate mobilization or removal of surface fines.

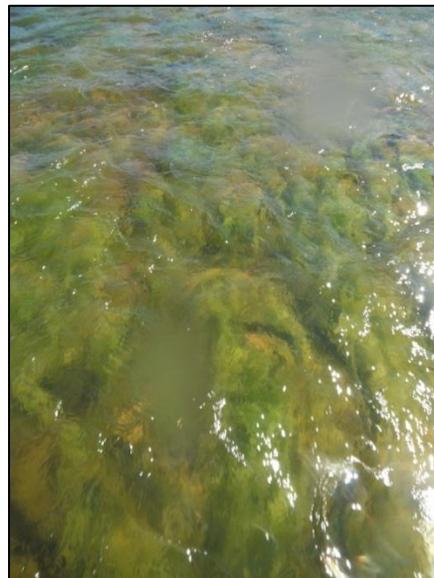
**Figure 3.125 – Green filamentous algae were blanketing much of the river bed at Above Dotsero post-runoff.**

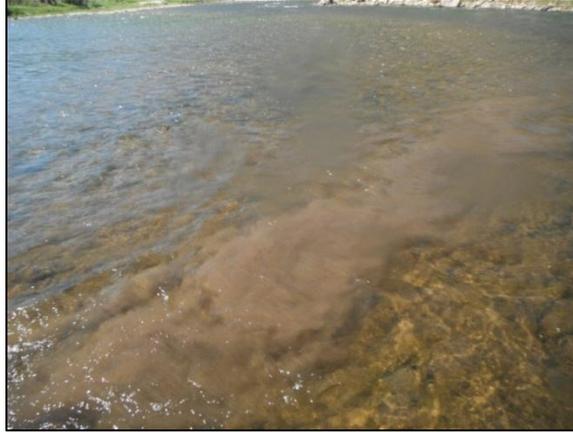
**Figure 3.126 – With each step clouds of fines would appear downstream at Above Dotsero post-runoff.**

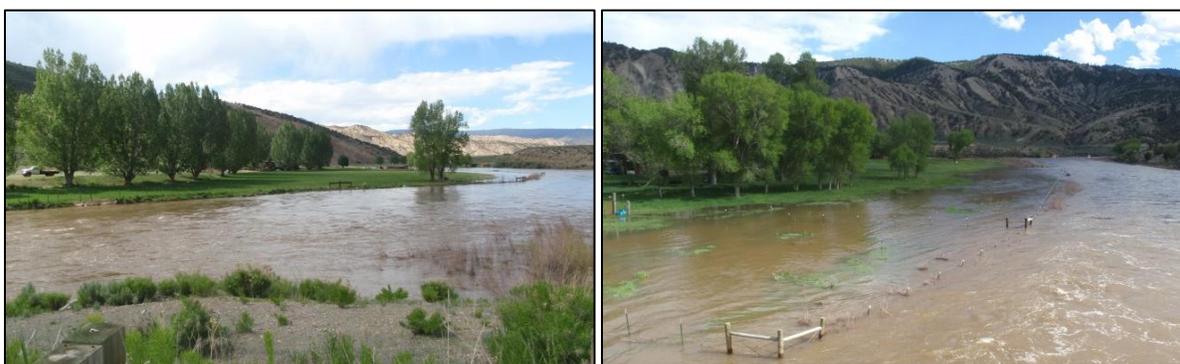
**Figure 4.1 – In the corridor from Red Dirt Creek to Dotsero, many private lands maintain little or no riparian buffer, potentially exacerbating bank erosion and limiting local-scale habitat for animal communities dependent on the riparian zone. An outreach campaign and guidance/support on riparian stewardship for riverside landowners can help improve this issue in the reach, which is experiencing increased recreational use from float boaters and fishermen due to access improvements by Eagle County.**

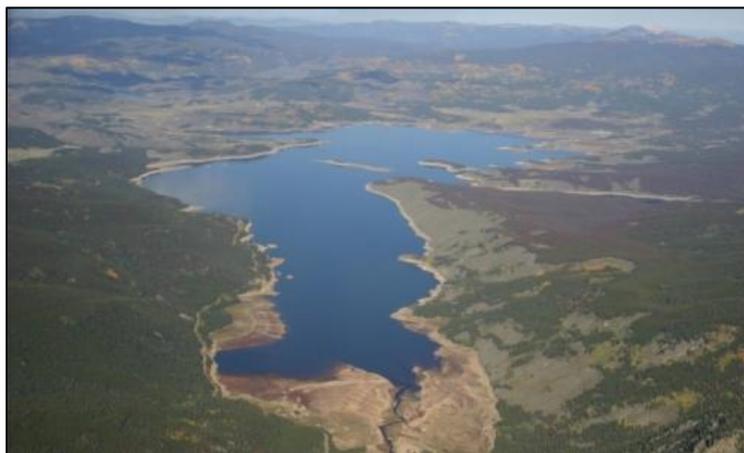
**Figure B.2 – Lake Granby dams up the Colorado River downstream of Shadow Mountain Reservoir ([http://www.allwinterpark.com/lakes\\_rivers\\_falls/lake\\_granby.php](http://www.allwinterpark.com/lakes_rivers_falls/lake_granby.php)).**

The Colorado River drains out of Shadow Mountain Reservoir and flows into Lake Granby (Figure B.2). Lake Granby was constructed between 1942 and 1949 by the BOR and is operated by the NCWCD. The main purpose of the reservoir is to store water to be sent over to the East Slope. The maximum capacity of Lake Granby is 539,758 AF.
